DRAFT Analysis of Brownfield Cleanup Alternatives Report

Former Markwardt Brothers Garage
North 1st Avenue and West Chocktoot Street
Chiloquin, Klamath County, Oregon 97624

Prepared for: City of City of Chiloquin
USEPA Cooperative Agreement: BF-02J00701-0

Cardo Project# CHILOQ200

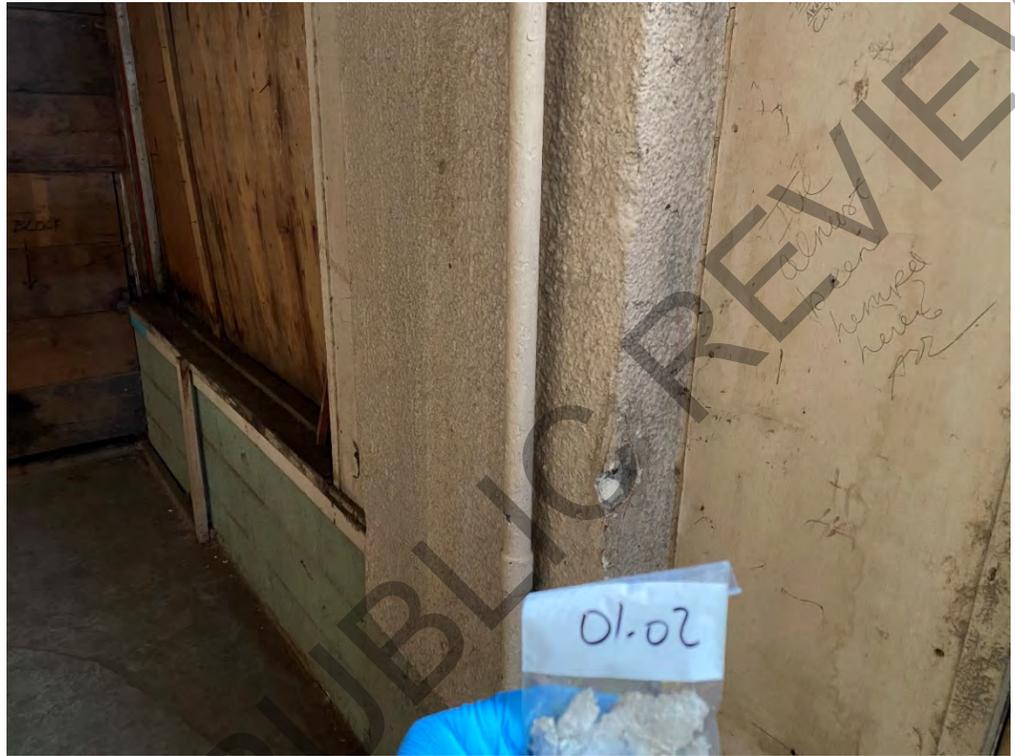
Confirmed ACM: White skim coat on plaster surfacing located in Room 2.

Given condition and location, the identified ACM will be properly abated by an Oregon-licensed abatement firm in accordance with the Environmental Protection Agency's (EPA) Asbestos Hazardous Emergency Response Act (AHERA) and the Occupational Safety and Health Administration (OSHA) regulations.

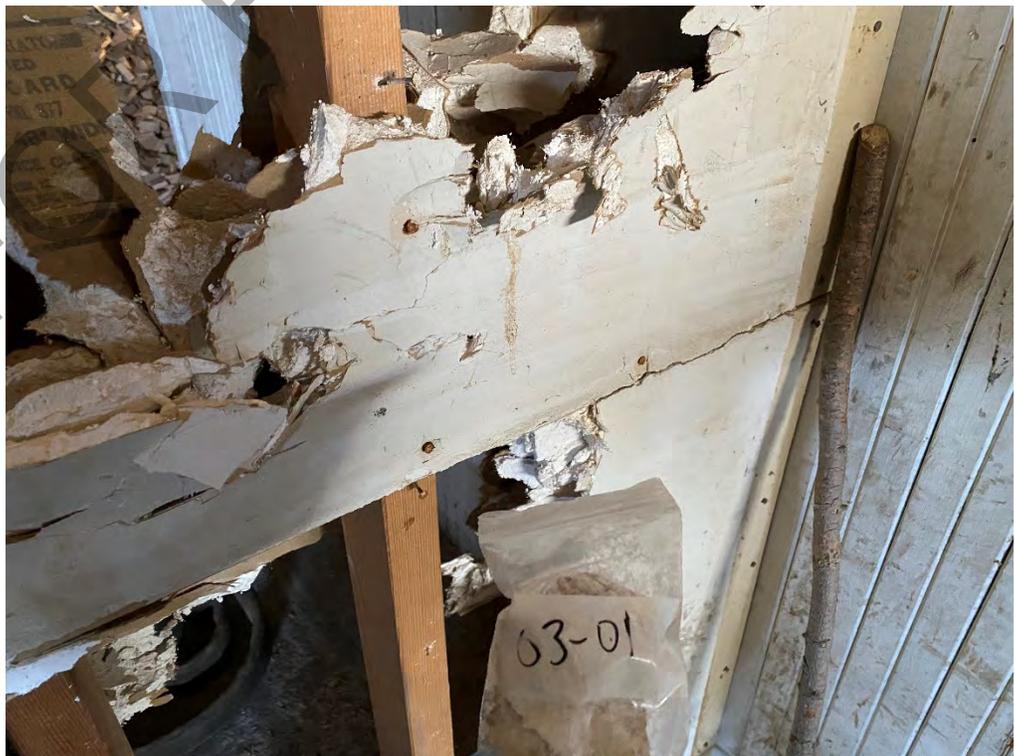
Photo No.
2

Confirmed ACM: White texture and joint compound on drywall located in Room 2.

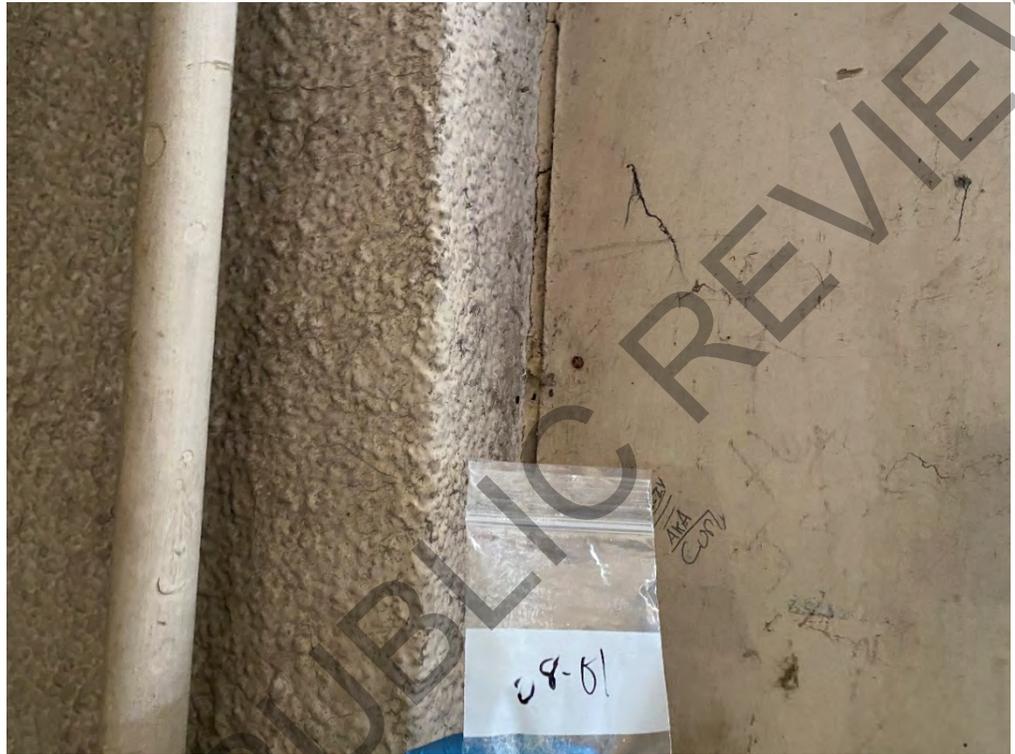
Description:
Confirmed ACM: Interior white caulk located in Room 2.

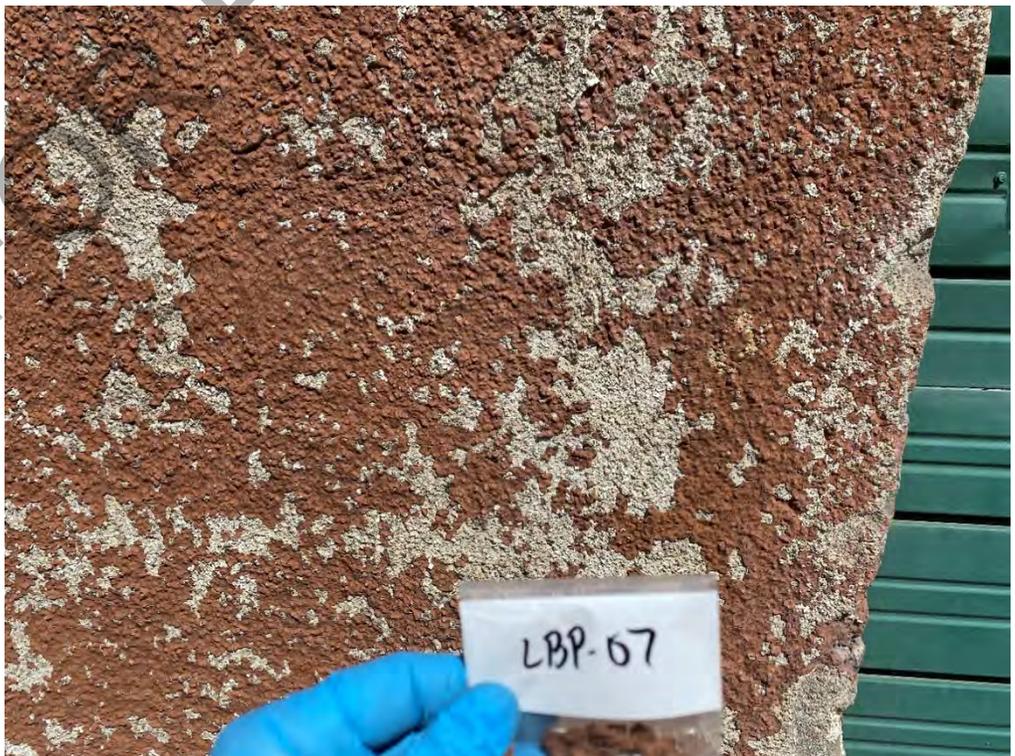
Photo No.
4

Description:
Confirmed ACM: Exterior red paint on plaster surfacing.

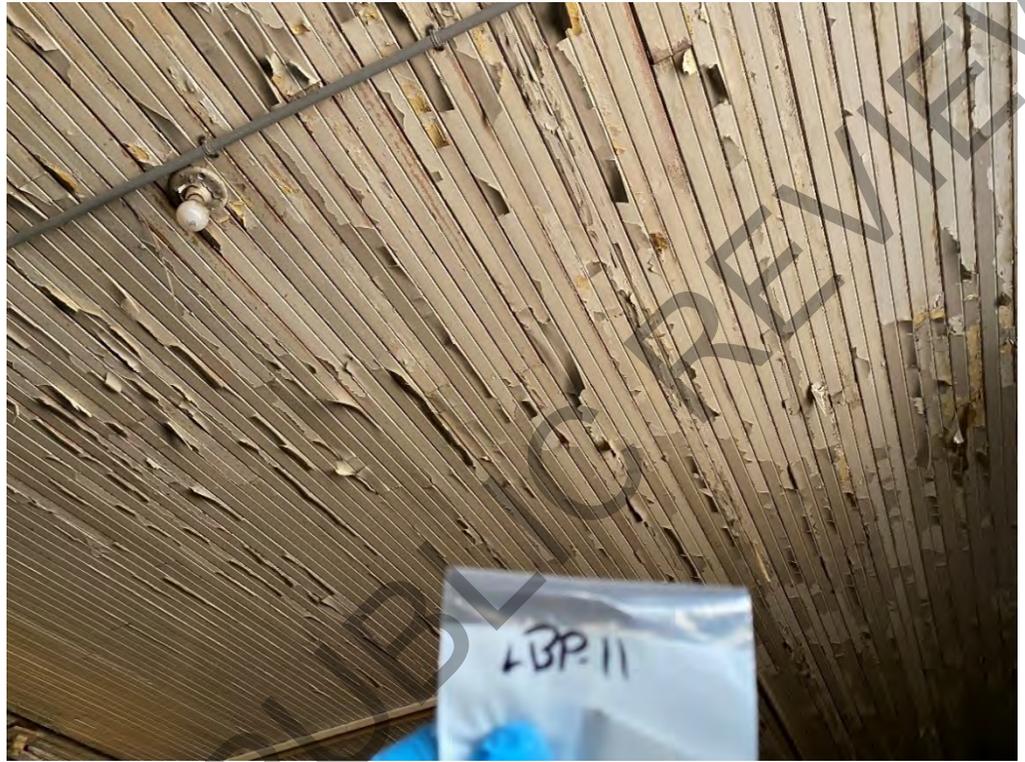
Description:
Confirmed LBP: Interior tan/gray paint on wood ceiling located in Room 2.

Given its condition and location, the identified lead-based paint will be abated by a licensed abatement firm in accordance with EPA and OSHA regulations.

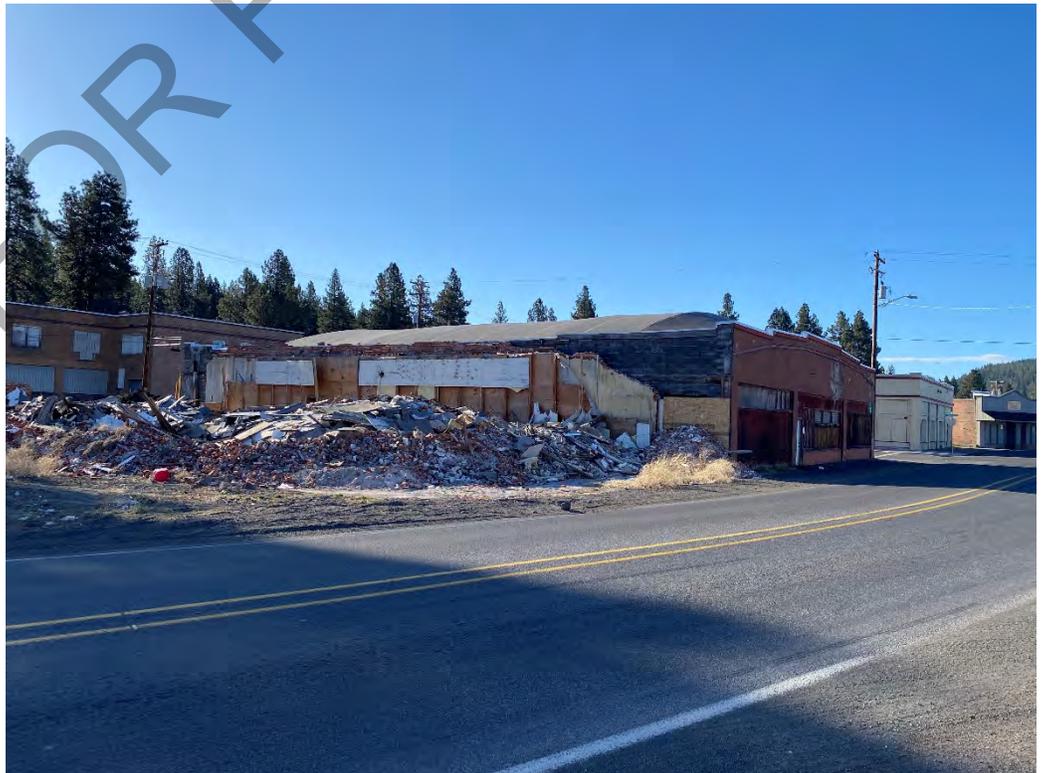
Photo No.
6

During the inspection, suspect building materials were observed in the exterior building debris from the former attached north building (former Chiloquin Mercantile); however, this material was not sampled and was identified in the report as presumed asbestos containing materials (PACM).

Description:
Pile of building debris is PACM.
