RE: Hotel Building Structural Observation

MDS Project # 3422

Site Address: 117 Chocktoot Street
Chiloquin, OR,

Project Name: Chocktoot Hotel Building

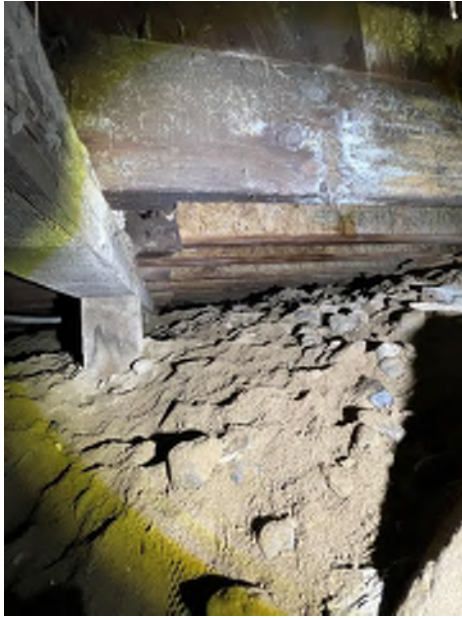
floor. Several of the posts are supported in turn by wood beam footings bearing directly on the soil. Additionally, a few of the timber footings were perched directly adjacent a vertical cut in the soil behind a concrete "Basement" wall. This condition should be remediated to provide adequate stability to the soil.

Photo No. 1 (Crawlspace post on dirt)

- Remove all untreated timber footings in direct contact with the ground and replace them with properly sized reinforced spread concrete footings.
- Footings supported adjacent vertical cuts in the soil should have crushed gravel or some other compacted medium placed between the concrete "basement" wall and the footings to prevent instability of the soil below the footings.

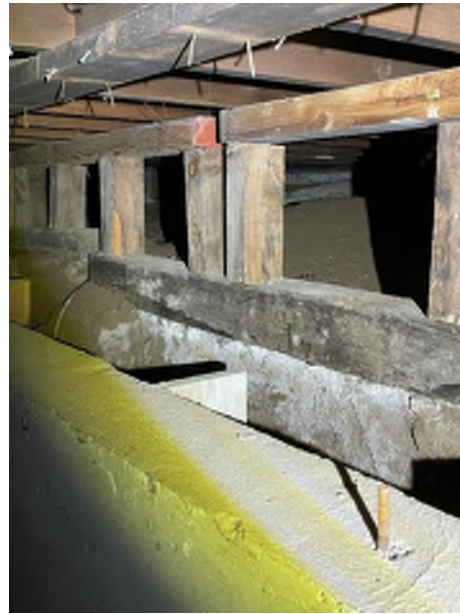
Photo No. 2 (Crawlspace footing a vert. soil)

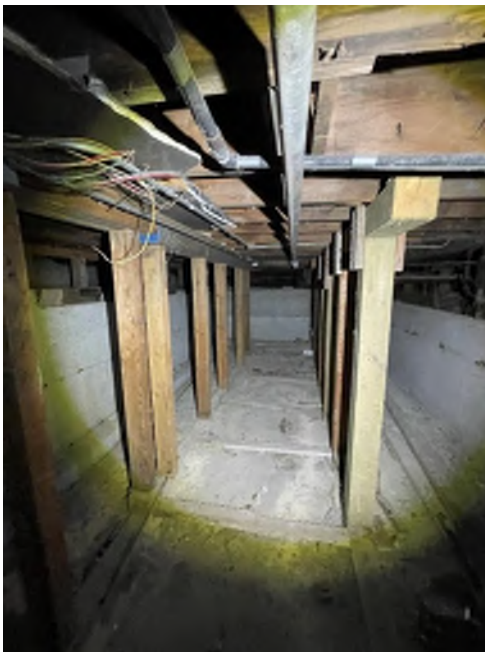
Photo No. 3 (Crawlspace "Basement")

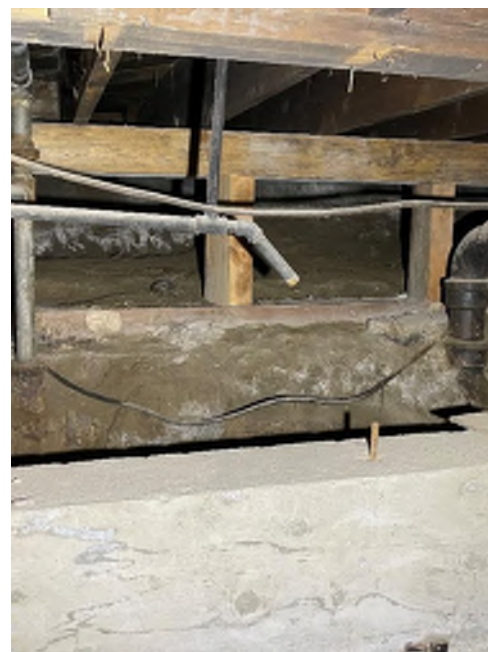
Photo No.4 (Timber footings on dirt)

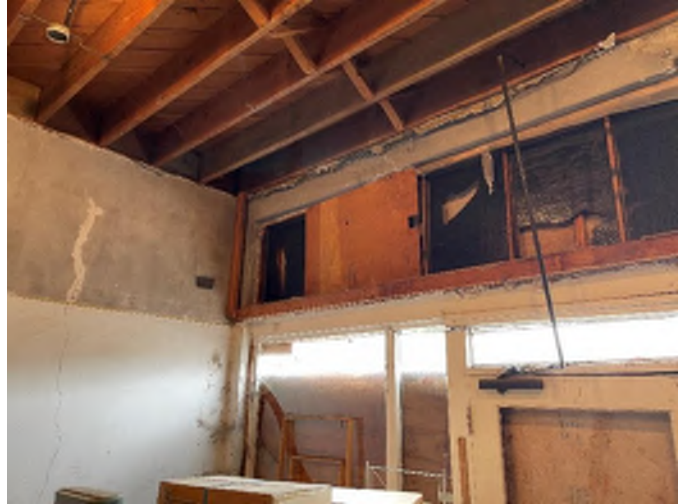
Photo No. 6 (Conc. beam at south wall)

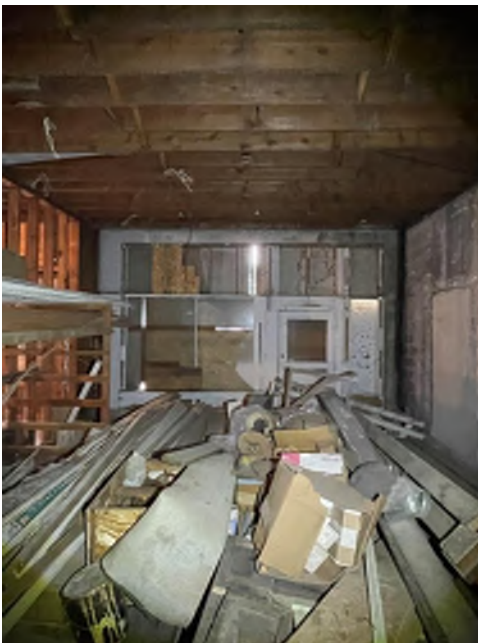
2. I reviewed the 2x12 upper floor joists for the current spans assuming a residential loading. Given the residential loading, the joists on the west side (16" OC spacing) are utilizing 90% of the available strength but are 8% over the current code value for deflection. The joists on the east side of the building (12" OC spacing) are utilizing 100% of their available strength and are 42% over the current code value for deflection. Since the joists appear to have sufficient strength under the fully loaded condition, I believe they are structurally adequate. Although they appear to have sufficient strength, if deflection is a concern, strengthening the floor system may be desired.

Photo No. 7 (West side floor joists)

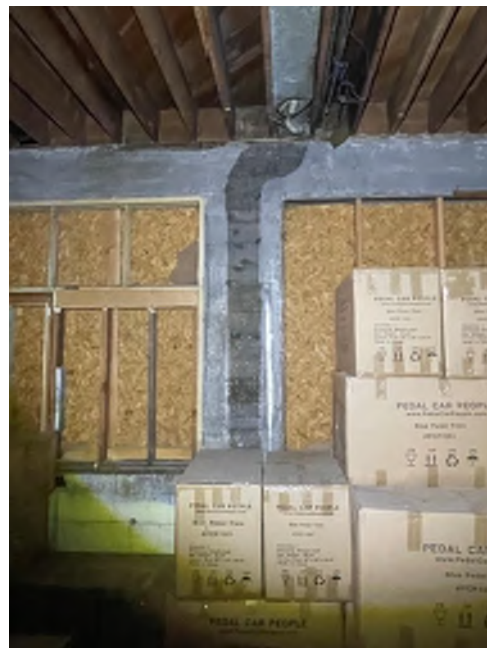
Photo No. 8 (Conc. post/ beams)

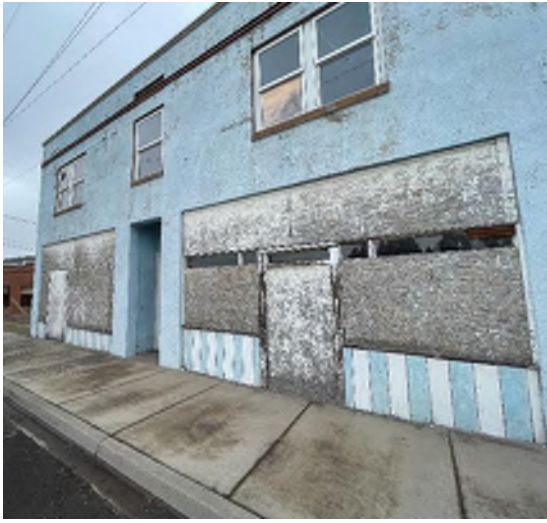
Photo No. 9 (Street front wall, south)

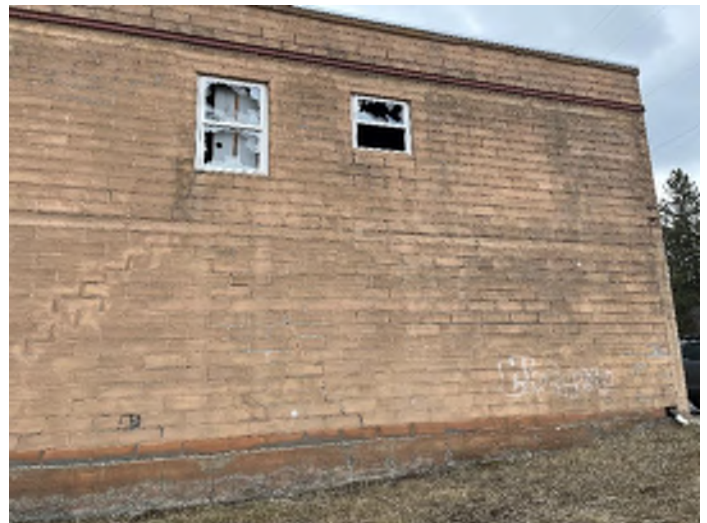
The exterior CMU appears to be generally in fair condition however some diagonal cracking in the masonry joints was noted from the exterior of the building in several locations indicating some level of differential settlement of the foundation elements. Additionally, at various locations around the exterior of the building, it appears that grout has come out of the joints over the years. The wood roof purlins, upper floor joists and their decking all appear to be in good condition. No rotted or damaged members were noted. There is one section of the upper floor joists on the west side of the building that appear to be sagging approximately 3/4" however no cracking or signs of damage were observed in those joists. The main floor joists & beams generally appear in fair condition however due to direct contact with the ground some of the supporting posts show signs of water intrusion. See the attached appendix for reference photos.

Photo No. 10 (Cracking west wall)

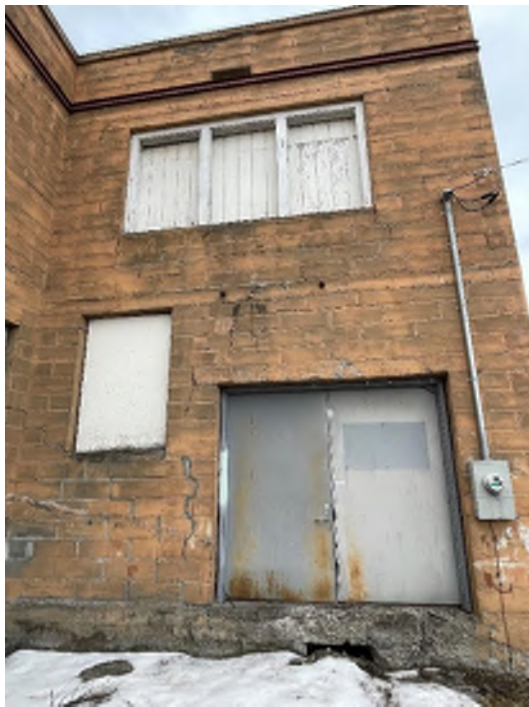
Photo No. 11 (North wall west side)

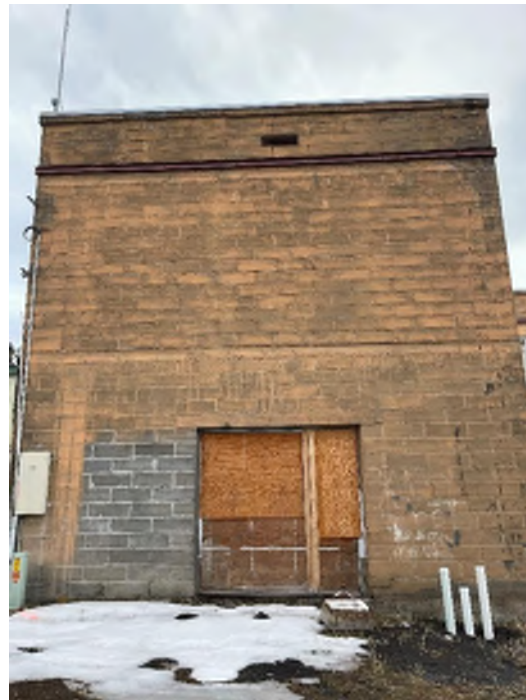
Photo No. 12 (North wall)

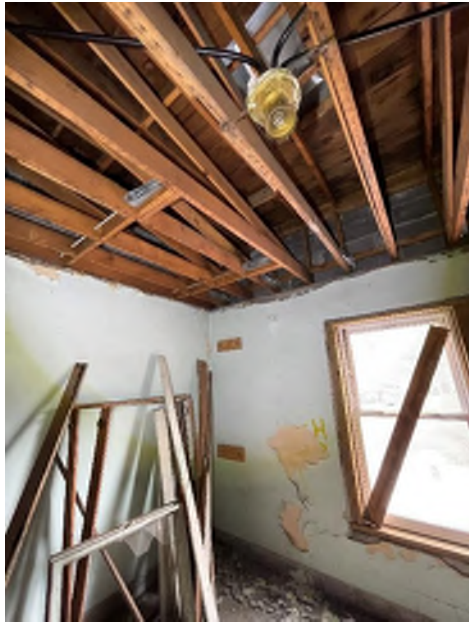
Photo No. 13 (RaftersW/ ties)

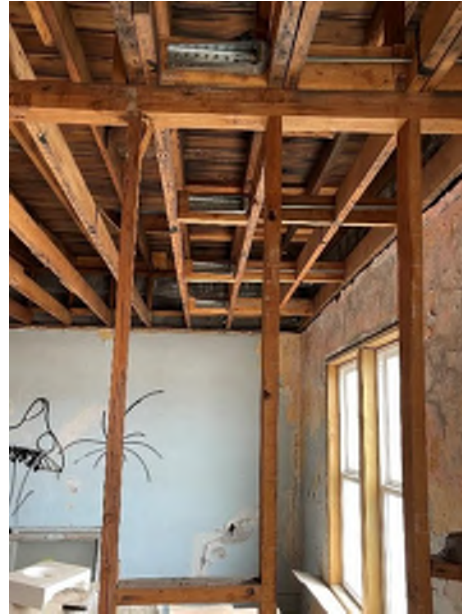
Photo No. 14 (RaftersW/ ties)

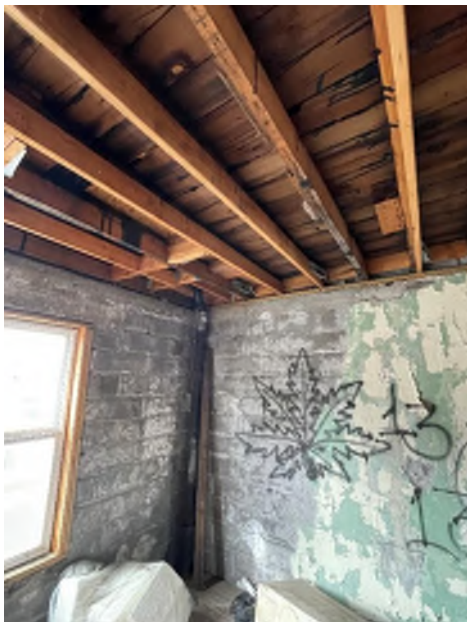
Photo No. 15 (RaftersW/ ties)

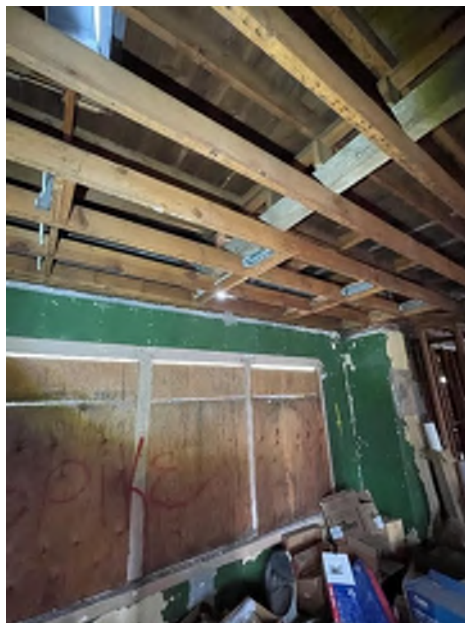
Photo No. 16 (RaftersW/ ties)

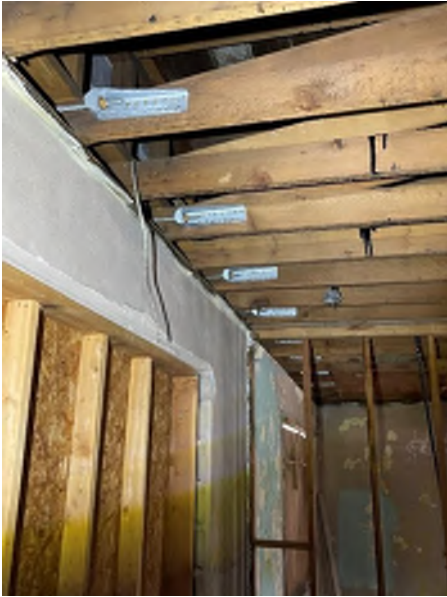
Photo No. 17 (Rafter ties)
