RE: Markwardt Building Structural Observation

MDS Project # 3422

Site Address: N 1st Ave. & W. Chocktoot Street
Chiloquin, OR 97624

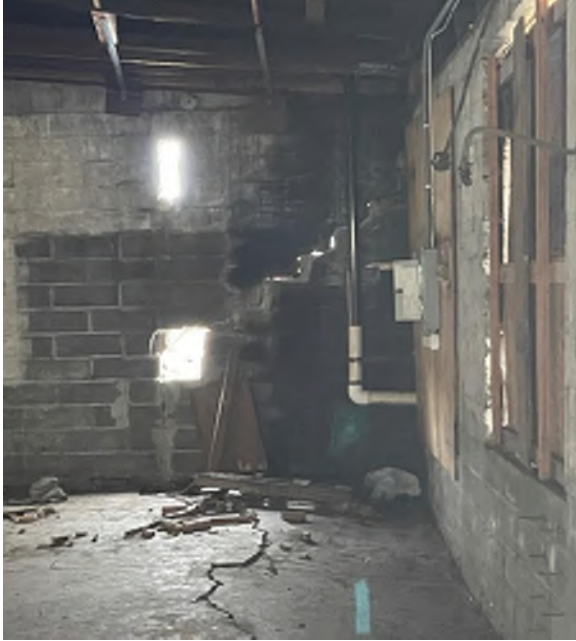
Photo #1 (Cracked/ separated Wall, east side)

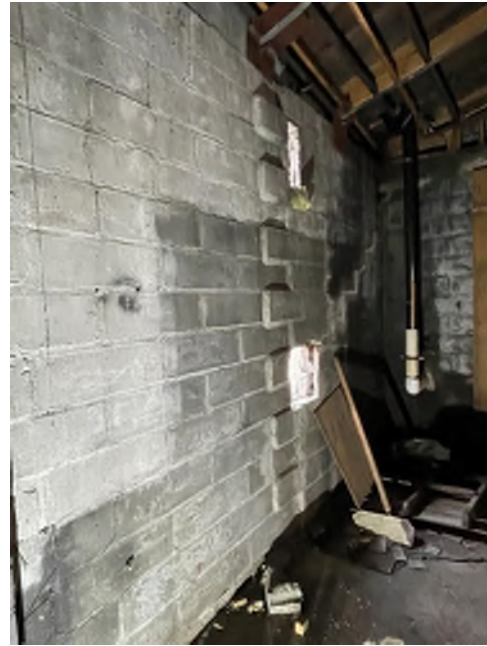
The general condition of this building is very poor. The north, east and south walls are constructed of concrete masonry units (CMU) and lean outward at the top in varying amounts from 1 ½" to 3 ½" depending on location. The south, east and west walls consist mostly of large window or door openings while the north wall is almost completely without openings. There are multiple settlement/ shear cracks in the masonry walls throughout the eastern half of the building with the worst occurring in the northeast corner where the masonry has separated due to a large vertical settlement of the east wall. One of the roof trusses toward the east end of the building has failed and has been repaired with steel plating which has subsequently failed by buckling. The roof deck is leaking in both the northeast and southeast corners leading to some rotting wood rafter members. The building foundations were not exposed at the time of our visit therefore no observation of the foundations could be made. One masonry pilaster on the north wall has been cut through to make a door opening. The remaining CMU around that door is showing

Photo #2 (Leaning URM corner)

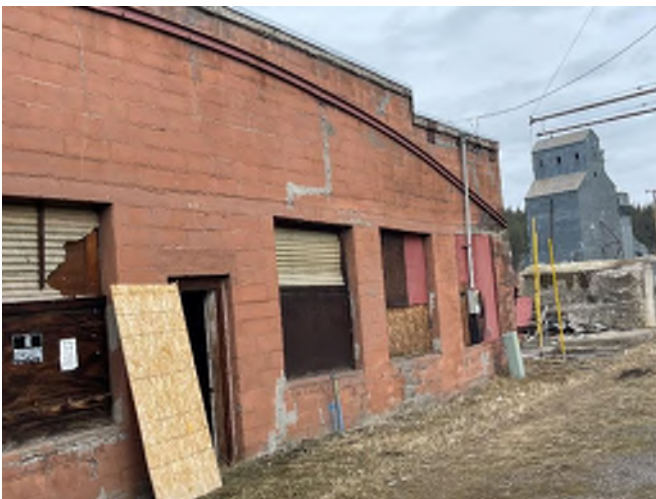
Photo #3 (West wall openings)

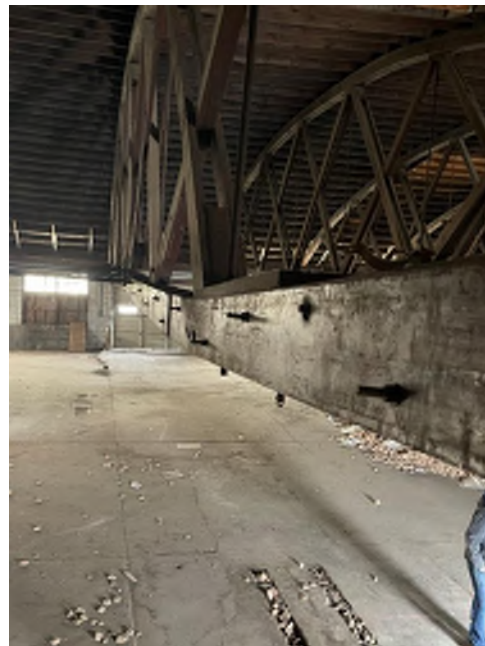
Photo #4 (Failed timber truss)

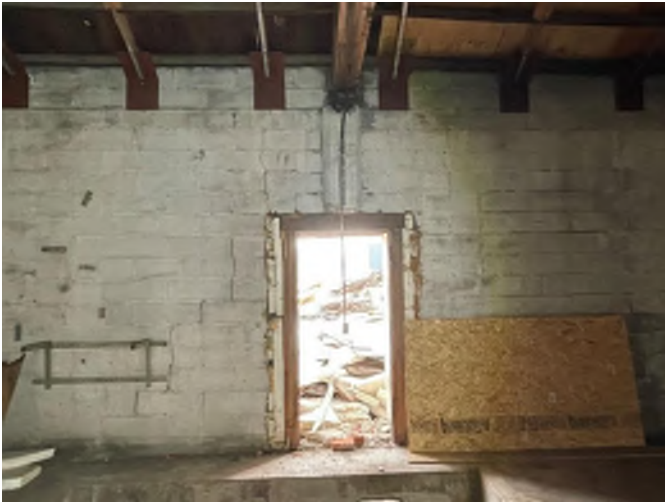
signs of stress evidenced by visible cracking in the adjacent mortar joints. Photos of the observations made and a map of their locations are attached in an appendix for reference.

Photo #5 (Door through pilaster)

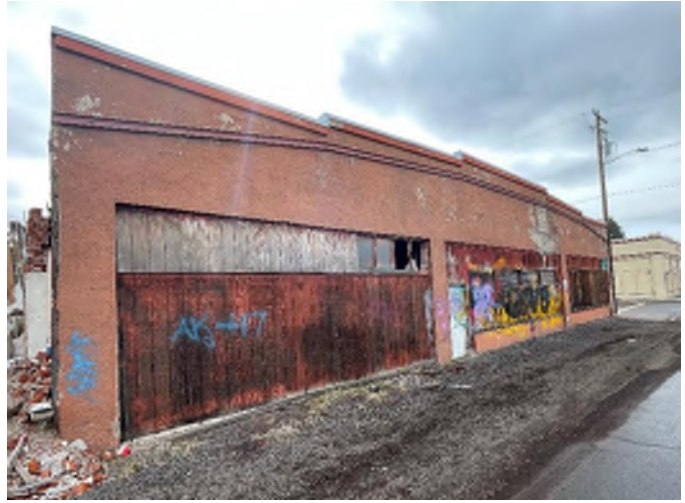
Photo #6 (West wall openings)

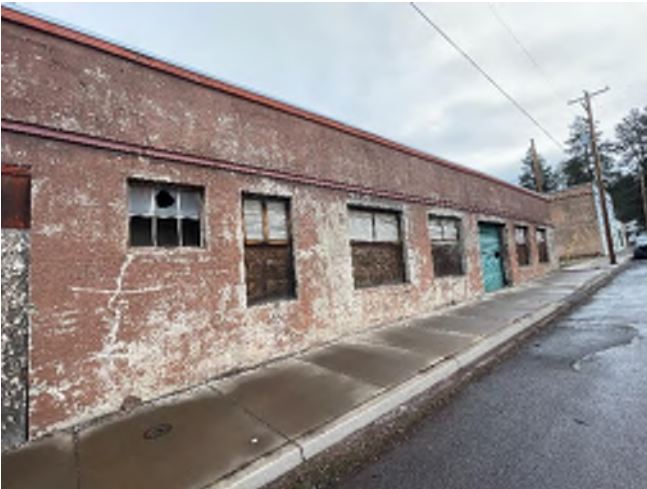
Photo #7 (South wall openings)

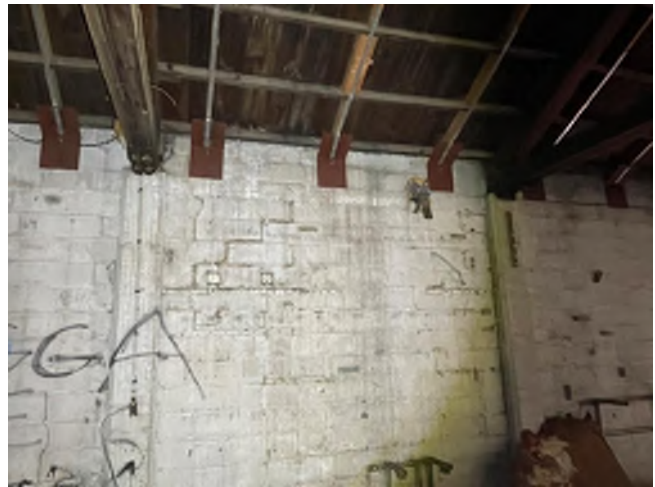
Photo #8 (Rafter to wall seismic ties)

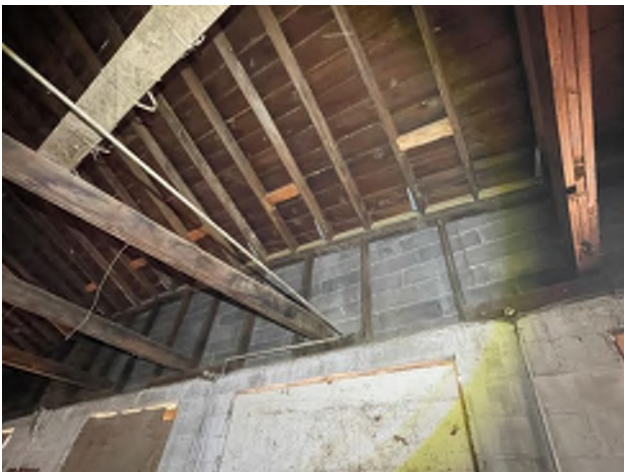
Photo #9 (Rafter to wall seismic ties)
